West Weaver Creek Salmonid Habitat Rehabilitation Project Summary

November 2017

Project Background

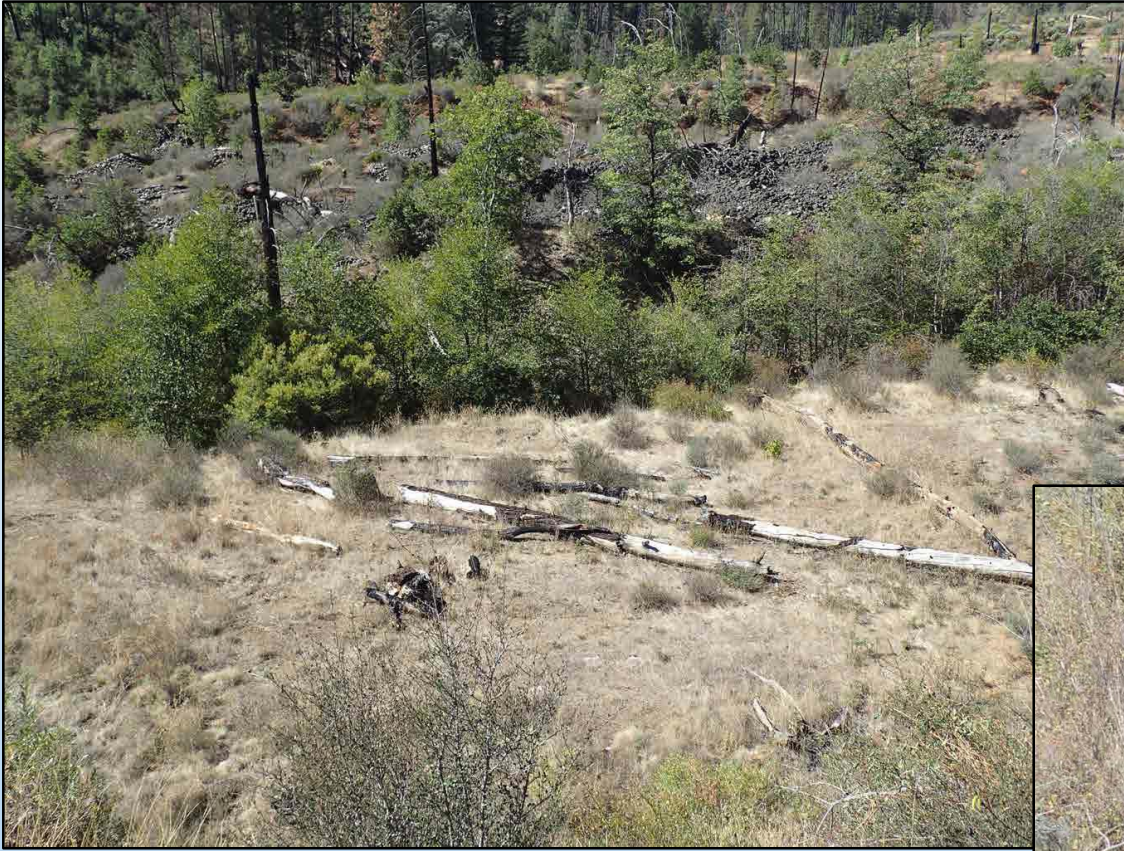
Prior Site Conditions

- Highly degraded from historical mining – clay pan and bedrock stream conditions

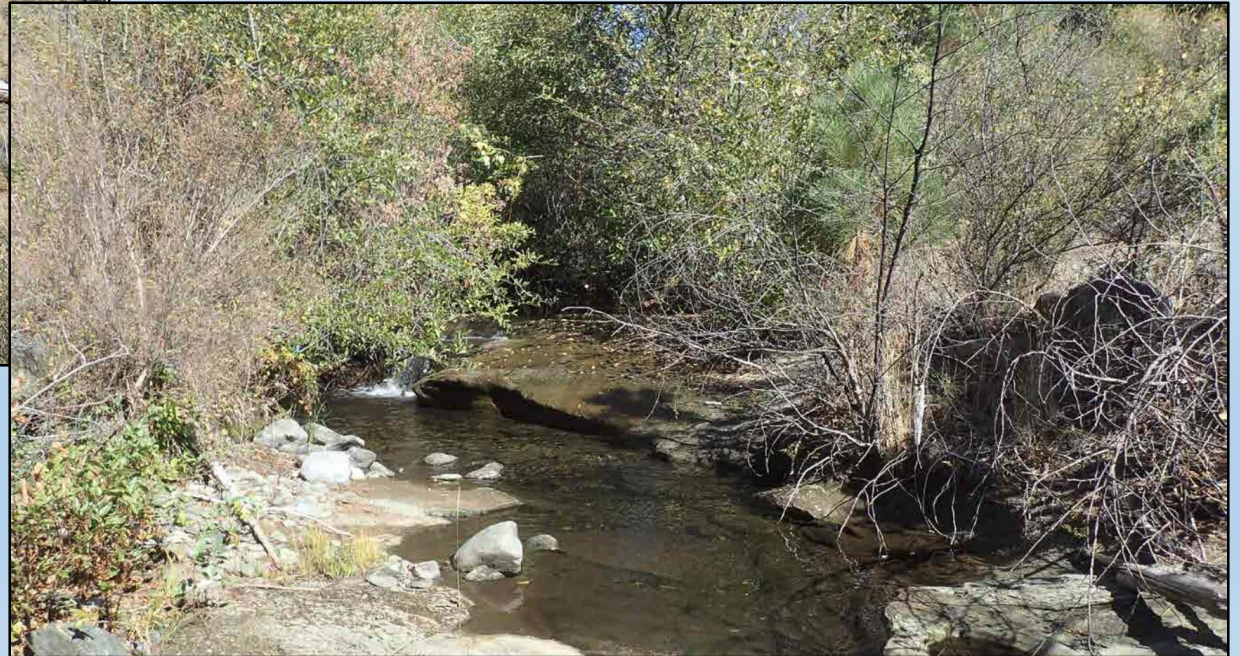
- Highly degraded from wildfire

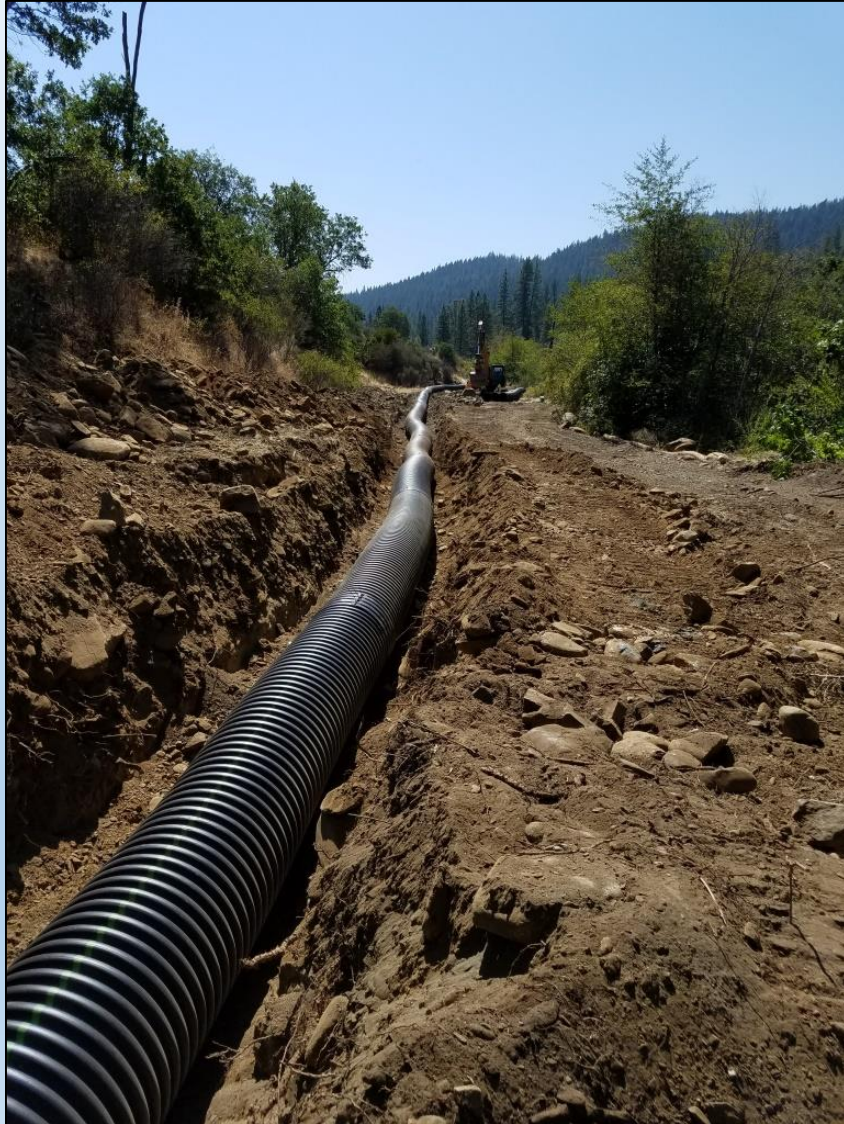
- High water year meant BIG diversion pipe
- CDFW staff stepped in on the rescue days so we didn't have to get the FYLF take permit – couldn't have done it without them!

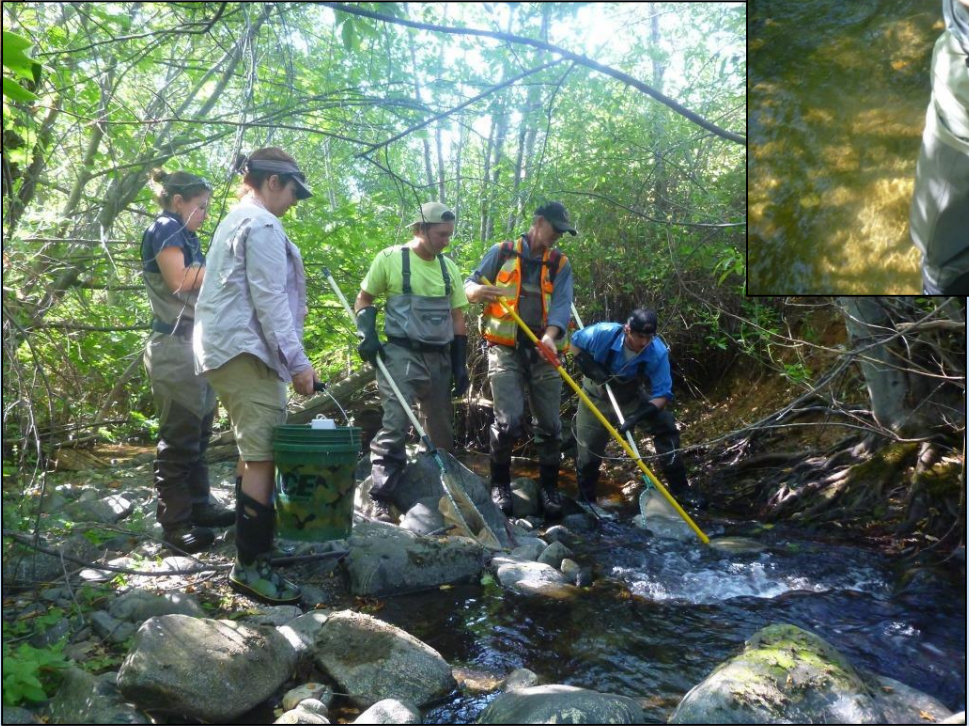
Downstream extent – add boulders to streambed

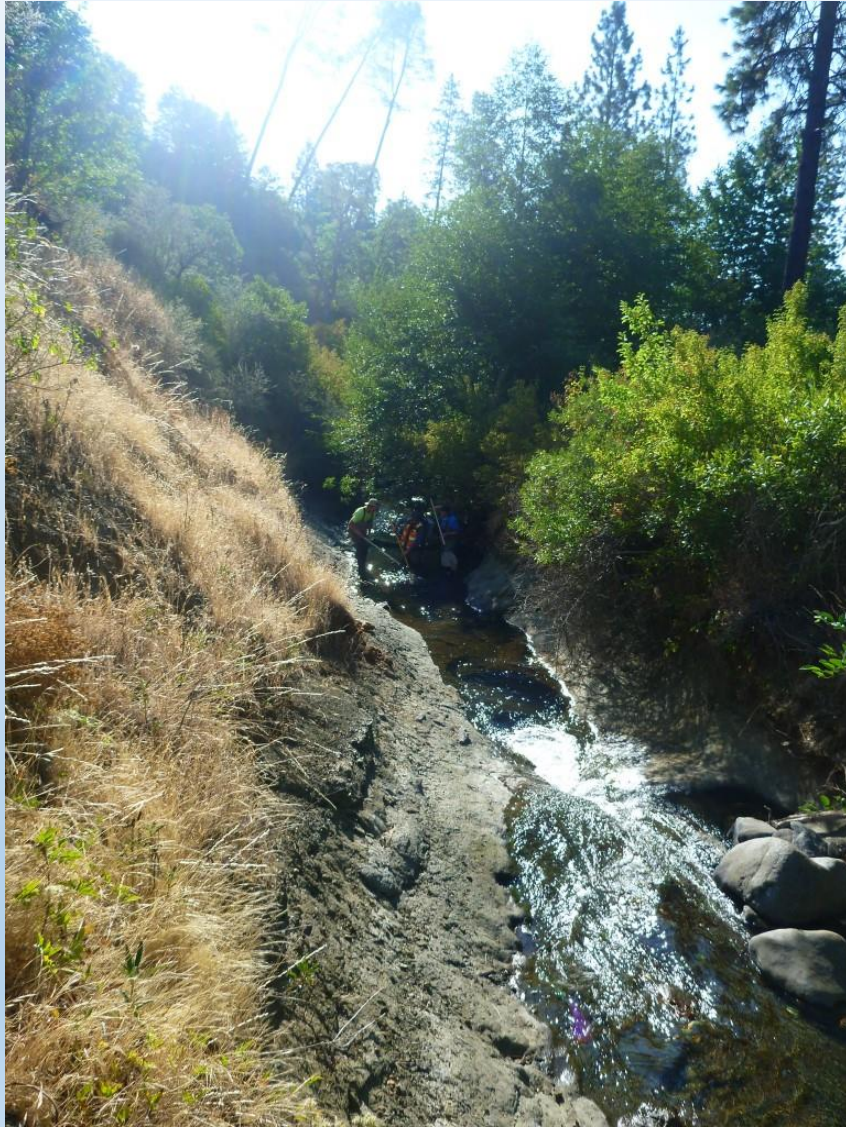
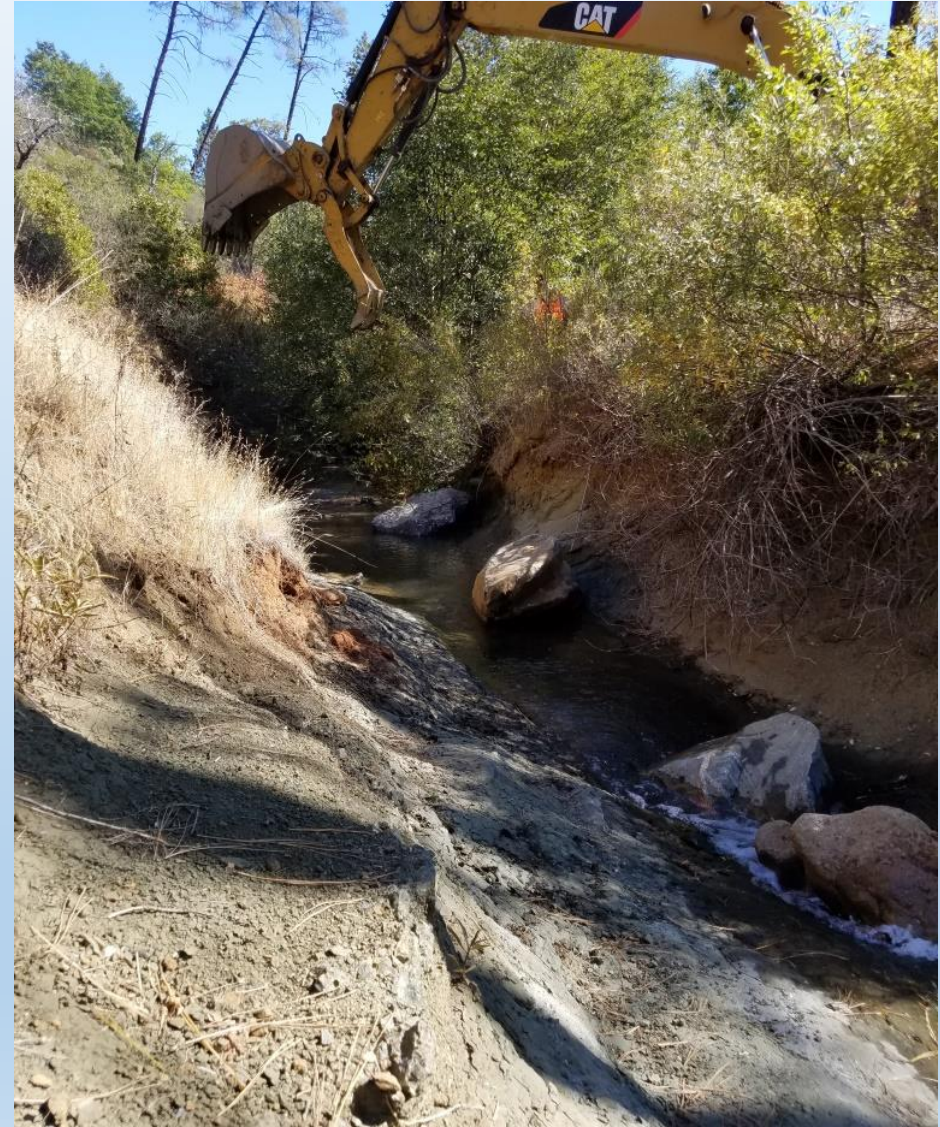
Downstream secondary channel August vs. November

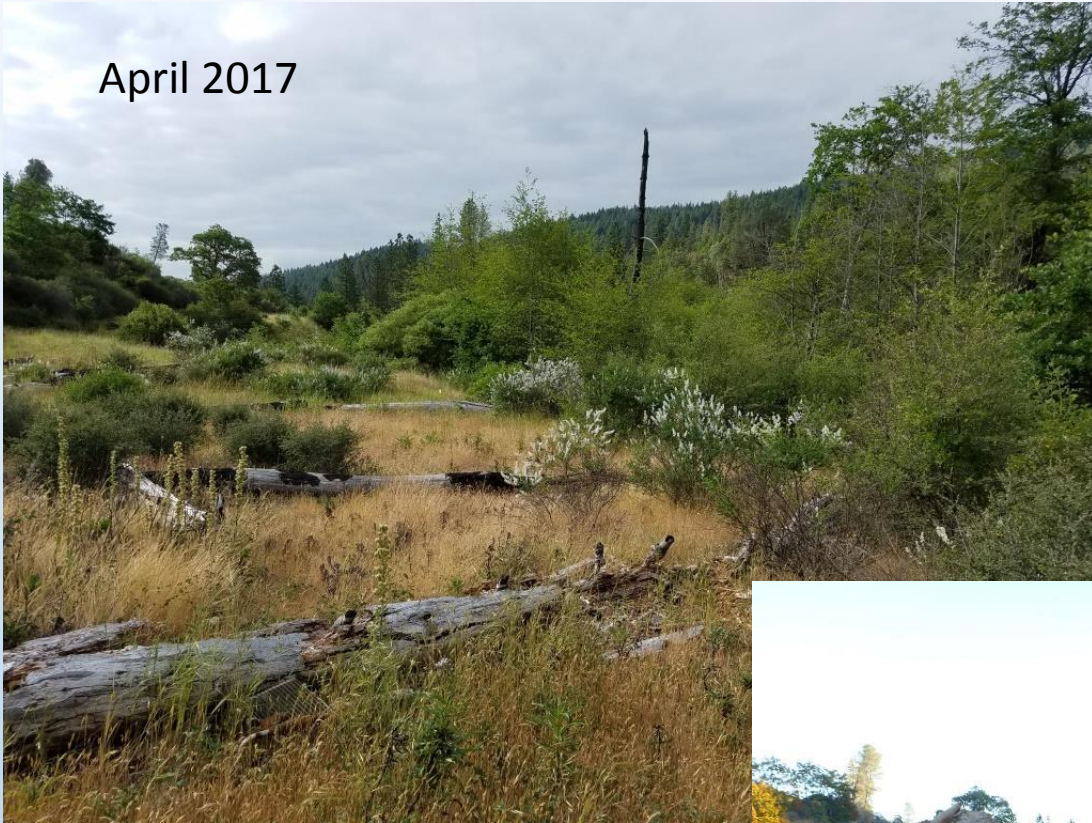
Step pools looking downstream

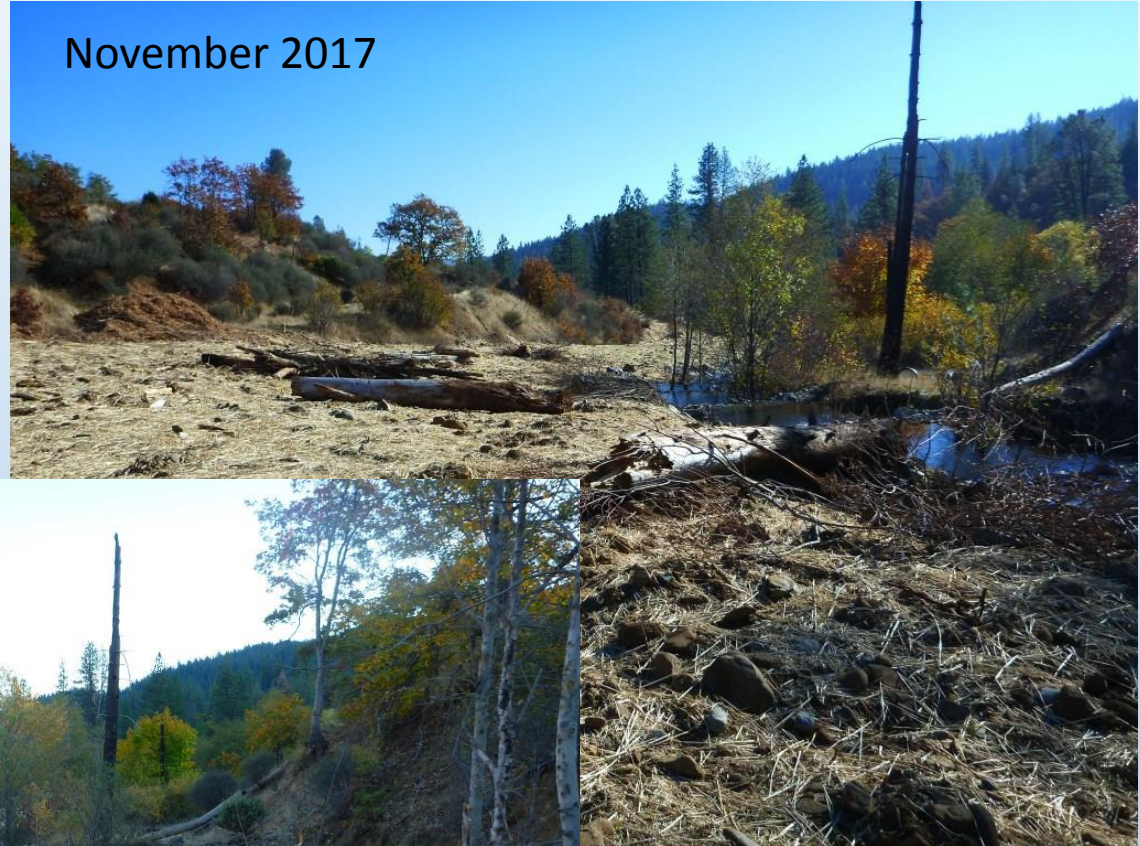
Downed debris from past fires was set aside during construction and then replaced on the floodplain to create micro-habitats.

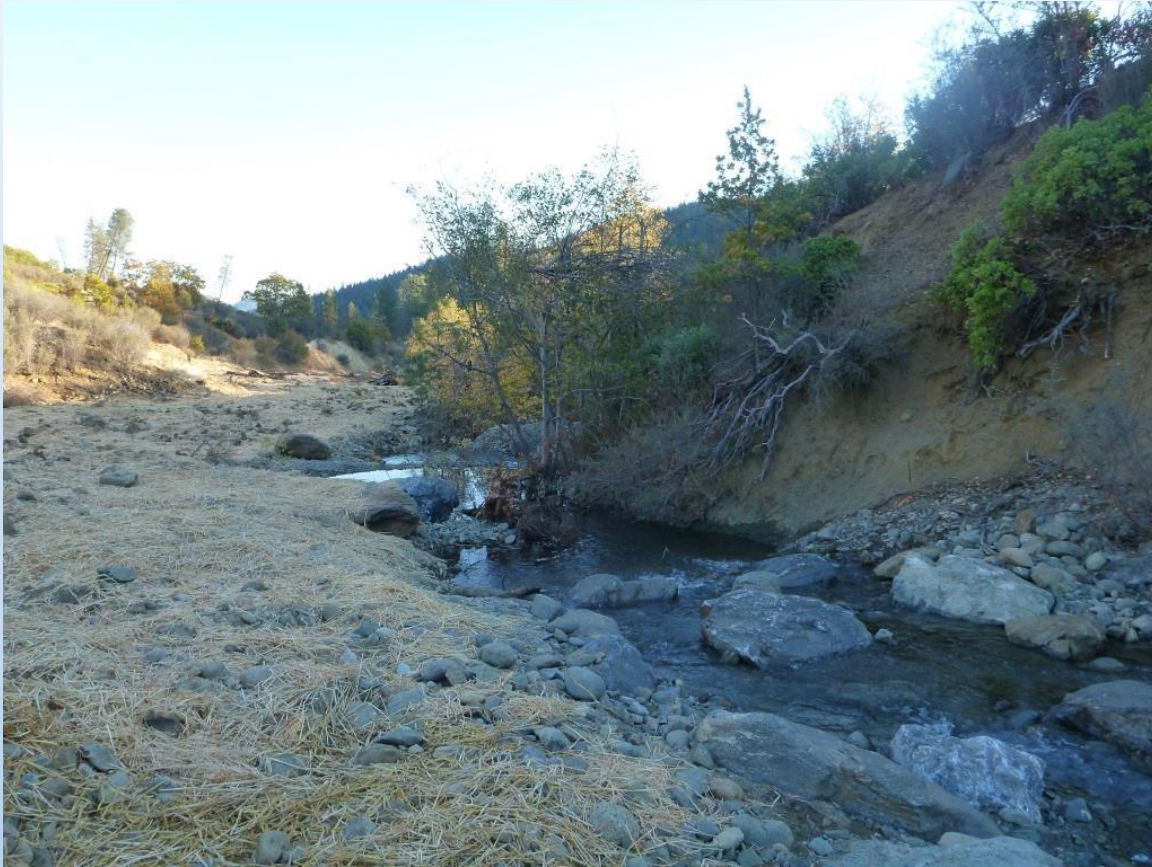
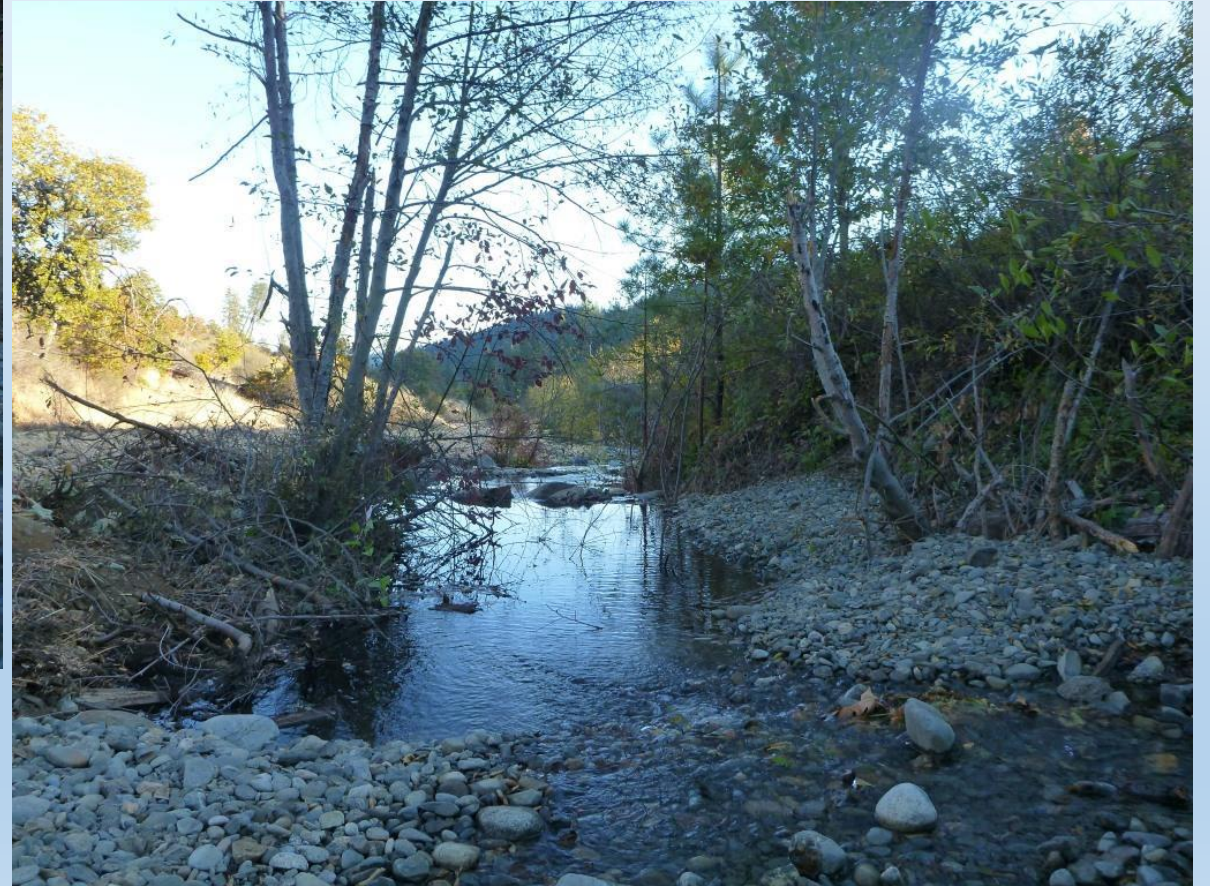
Boulder Cascades and Riffles
